REPORT ON FIRE RESISTANCE TEST **OF METAL DOORSET**

: Fire Resistance Test on Metal Doorset **Project**

BS EN 1634-1:2014+A1:2018

Report No. : G22094FU226158

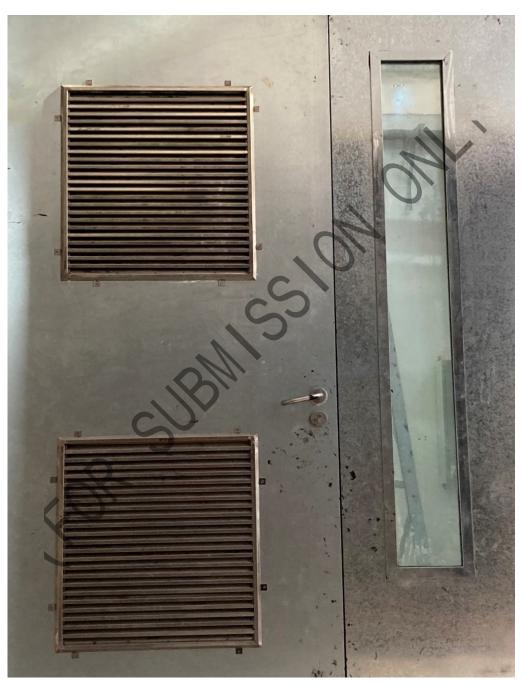
Photo 15 - The glass panel and louvers of the doorset after medium temperature test

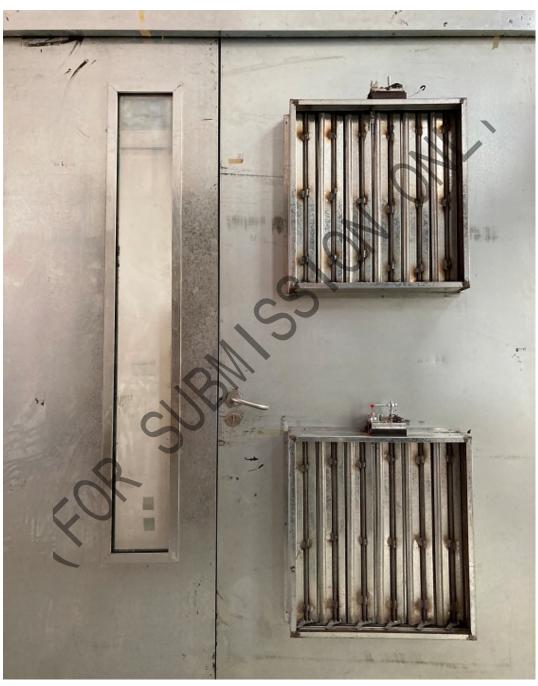
Photo 30 - The glass panel and louvers of the doorset after medium temperature test

48:21 Blur discolouration was visible on the exposed surface of the glass panel						
59:28	Test is terminated.					
b) After the test						
	Blur discolouration was visible on the exposed surface of the glass panel.					
Damages on the specimen	The intumescent fire seal with fins harden and damaged at the door frame and the door leaves.					
	No significant change was visible to the bottom smoke seal.					
Operability	The door leaves was able to be opened manually.
